# Bathymetric and Velocimetric Surveys at Highway Bridges Crossing the Missouri and Mississippi Rivers on the Periphery of Missouri, July–August 2018

By Richard J. Huizinga

Scientific Investigations Report 2020–5088

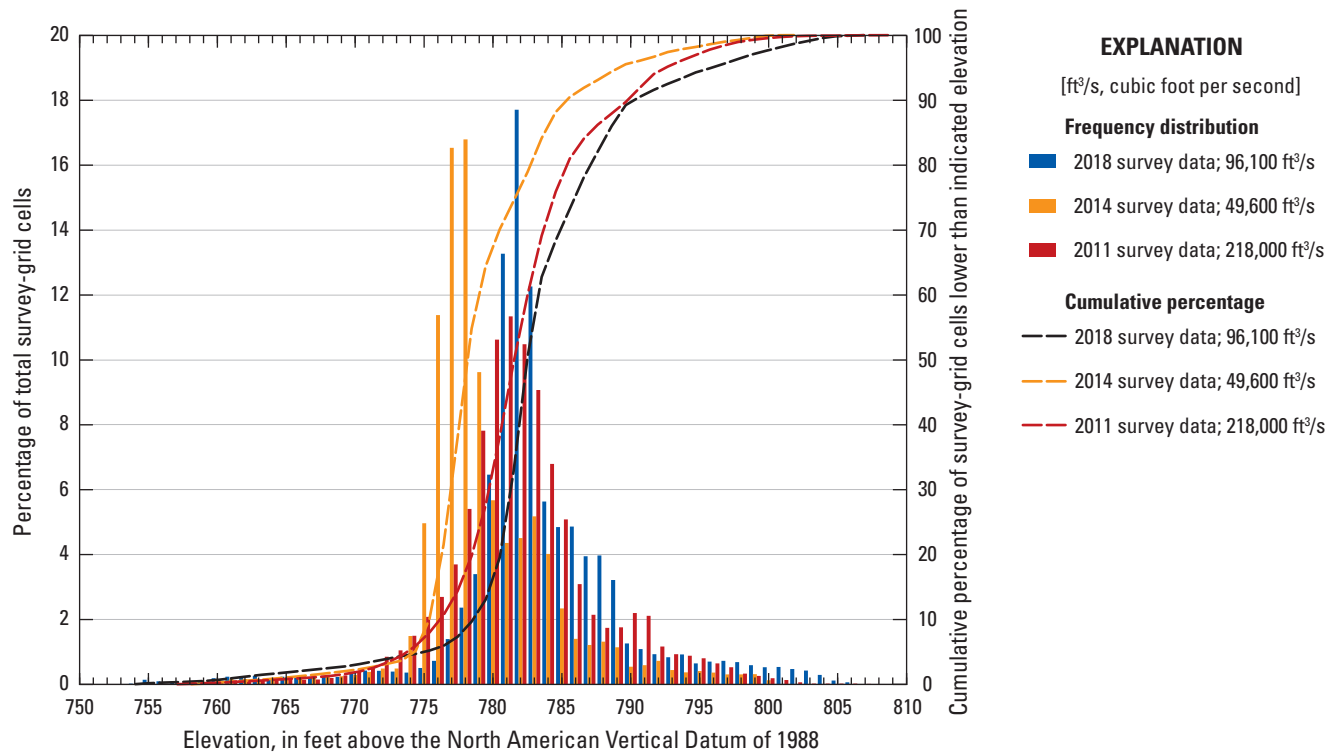
**Figure 13.** Frequency distribution of bed elevations for bathymetric survey-grid cells in 1-foot elevation bins on the Missouri River near dual bridge structure A3664 on U.S. Highway 36 at St. Joseph, Missouri, on July 16, 2018, compared to previous surveys (Huizinga, 2012, 2015).

The difference between the survey on July 16, 2018, and the previous nonflood survey on June 4, 2014 (fig. 15), indicates substantial deposition of nearly 30 ft throughout the reach from the 2014 to 2018 surveys, resulting in an average difference of +3.15 ft between the bathymetric surfaces (table 8). The net volume of cut in the reach from 2014 to 2018 was about 21,200 yd<sup>3</sup>, and the net volume of fill was about 141,200 yd<sup>3</sup>, resulting in a net gain of about 120,000 yd<sup>3</sup> of sediment. The frequency distribution of channel-bed elevations in 2018 was similar in shape to 2014, but with most of the survey-grid cells at elevations about 3 ft higher than in 2014 (fig. 13). The limited width extent of the 2014 survey

may affect the difference, as areas of erosion or deposition downstream from the spur dikes were not surveyed in 2014. Furthermore, a dredge barge was in operation near the downstream end of the surveyed reach in 2014 (see fig. 10 in Huizinga, 2015), and the dredging activity may have created overall scour in the reach in 2014 as sediment shifted to fill the downstream area being dredged. The dredge activity in 2014 may explain the generally lower cross section at the upstream bridge face in 2014 (fig. 14), as well as the lower elevations observed for 2014 in the frequency distribution and accumulation curve (fig. 13).

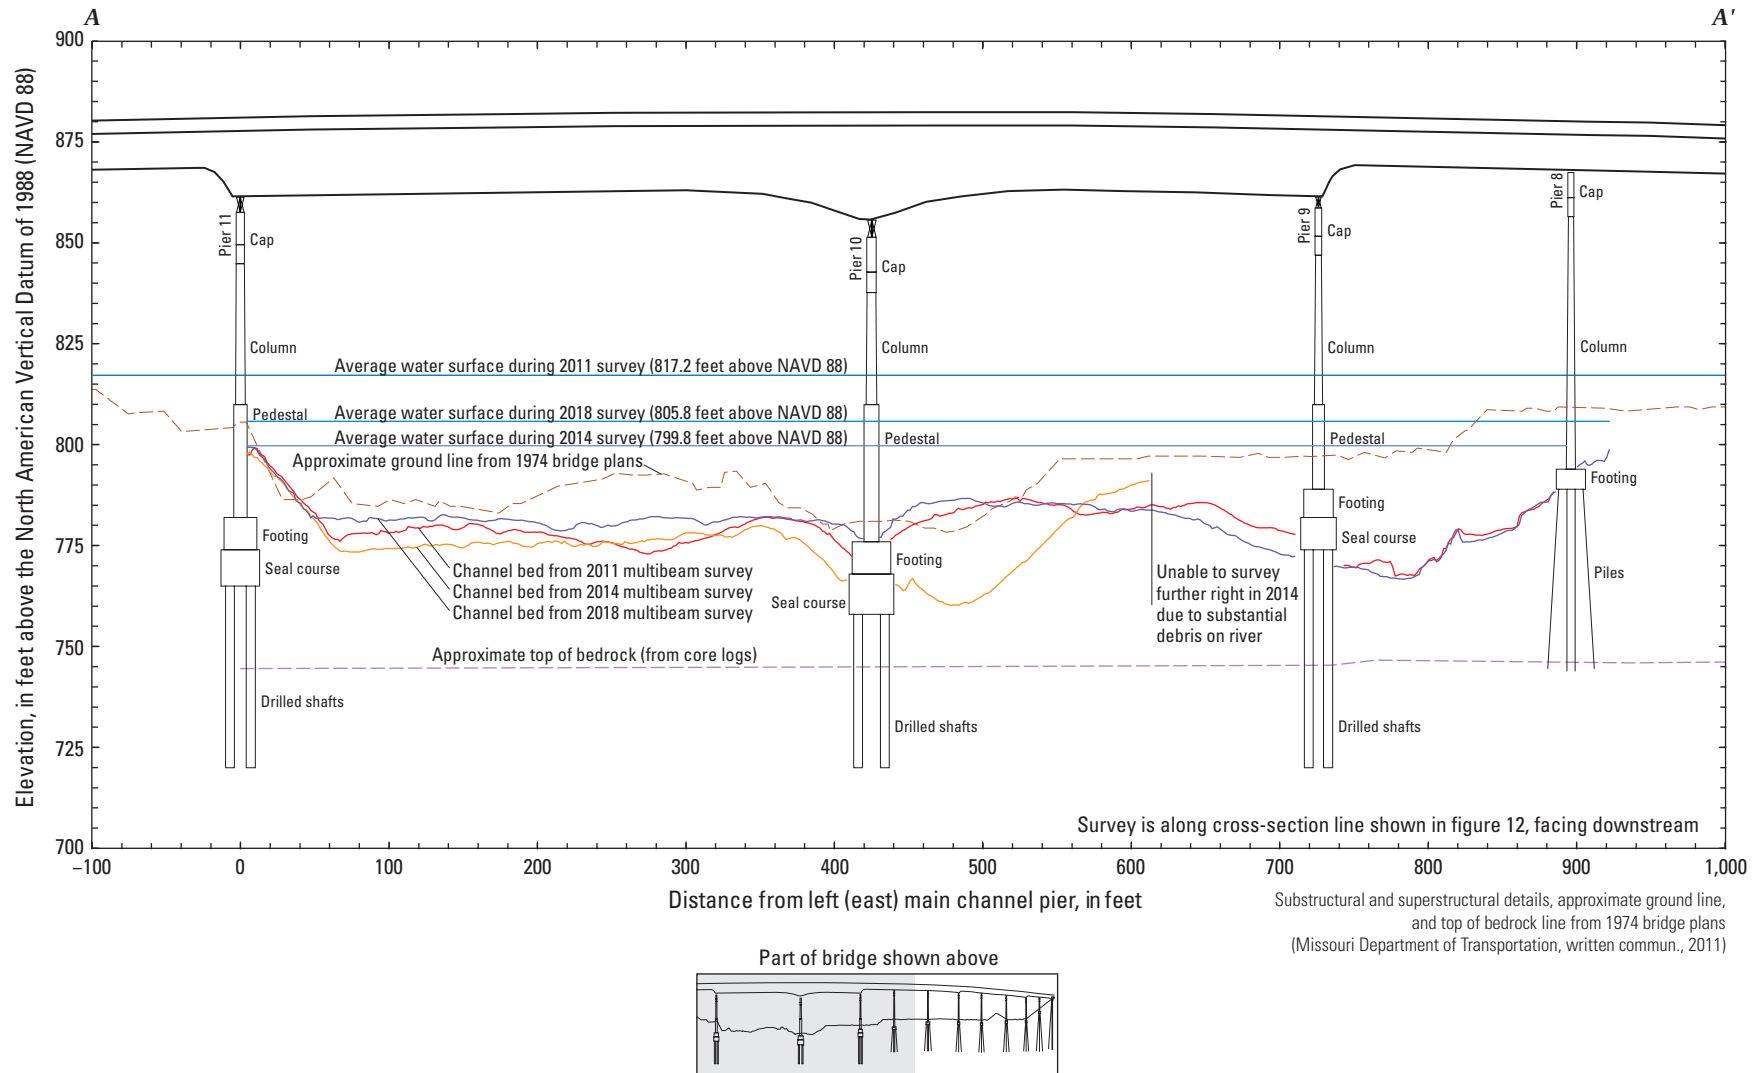
The minor scour hole near pier 10 was difficult to discern from nearby dunes and ripples (figs. 12, 1.2A, 1.2B), but had a minimum channel-bed elevation of about 777 ft (table 7). The top of the footing of pier 9 was evident on the upstream and left (east) sides, primarily because of the scour hole from the upstream spur dike (figs. 12, 1.2C, 1.2D). Information from bridge plans indicates that piers 9 and 10 are founded on shafts drilled into bedrock, with about 24 ft of bed material between the bottom of the scour hole and bedrock at the upstream face of pier 9 (table 7). The surveyed bed was generally similar to the multibeam survey on July 14, 2011, except on the left side of pier 10 (fig. 14).

**Figure 14.** Key features, substructural and superstructural details, and surveyed channel bed of dual bridge structure A3664 on U.S. Highway 36 crossing the Missouri River at St. Joseph, Missouri.

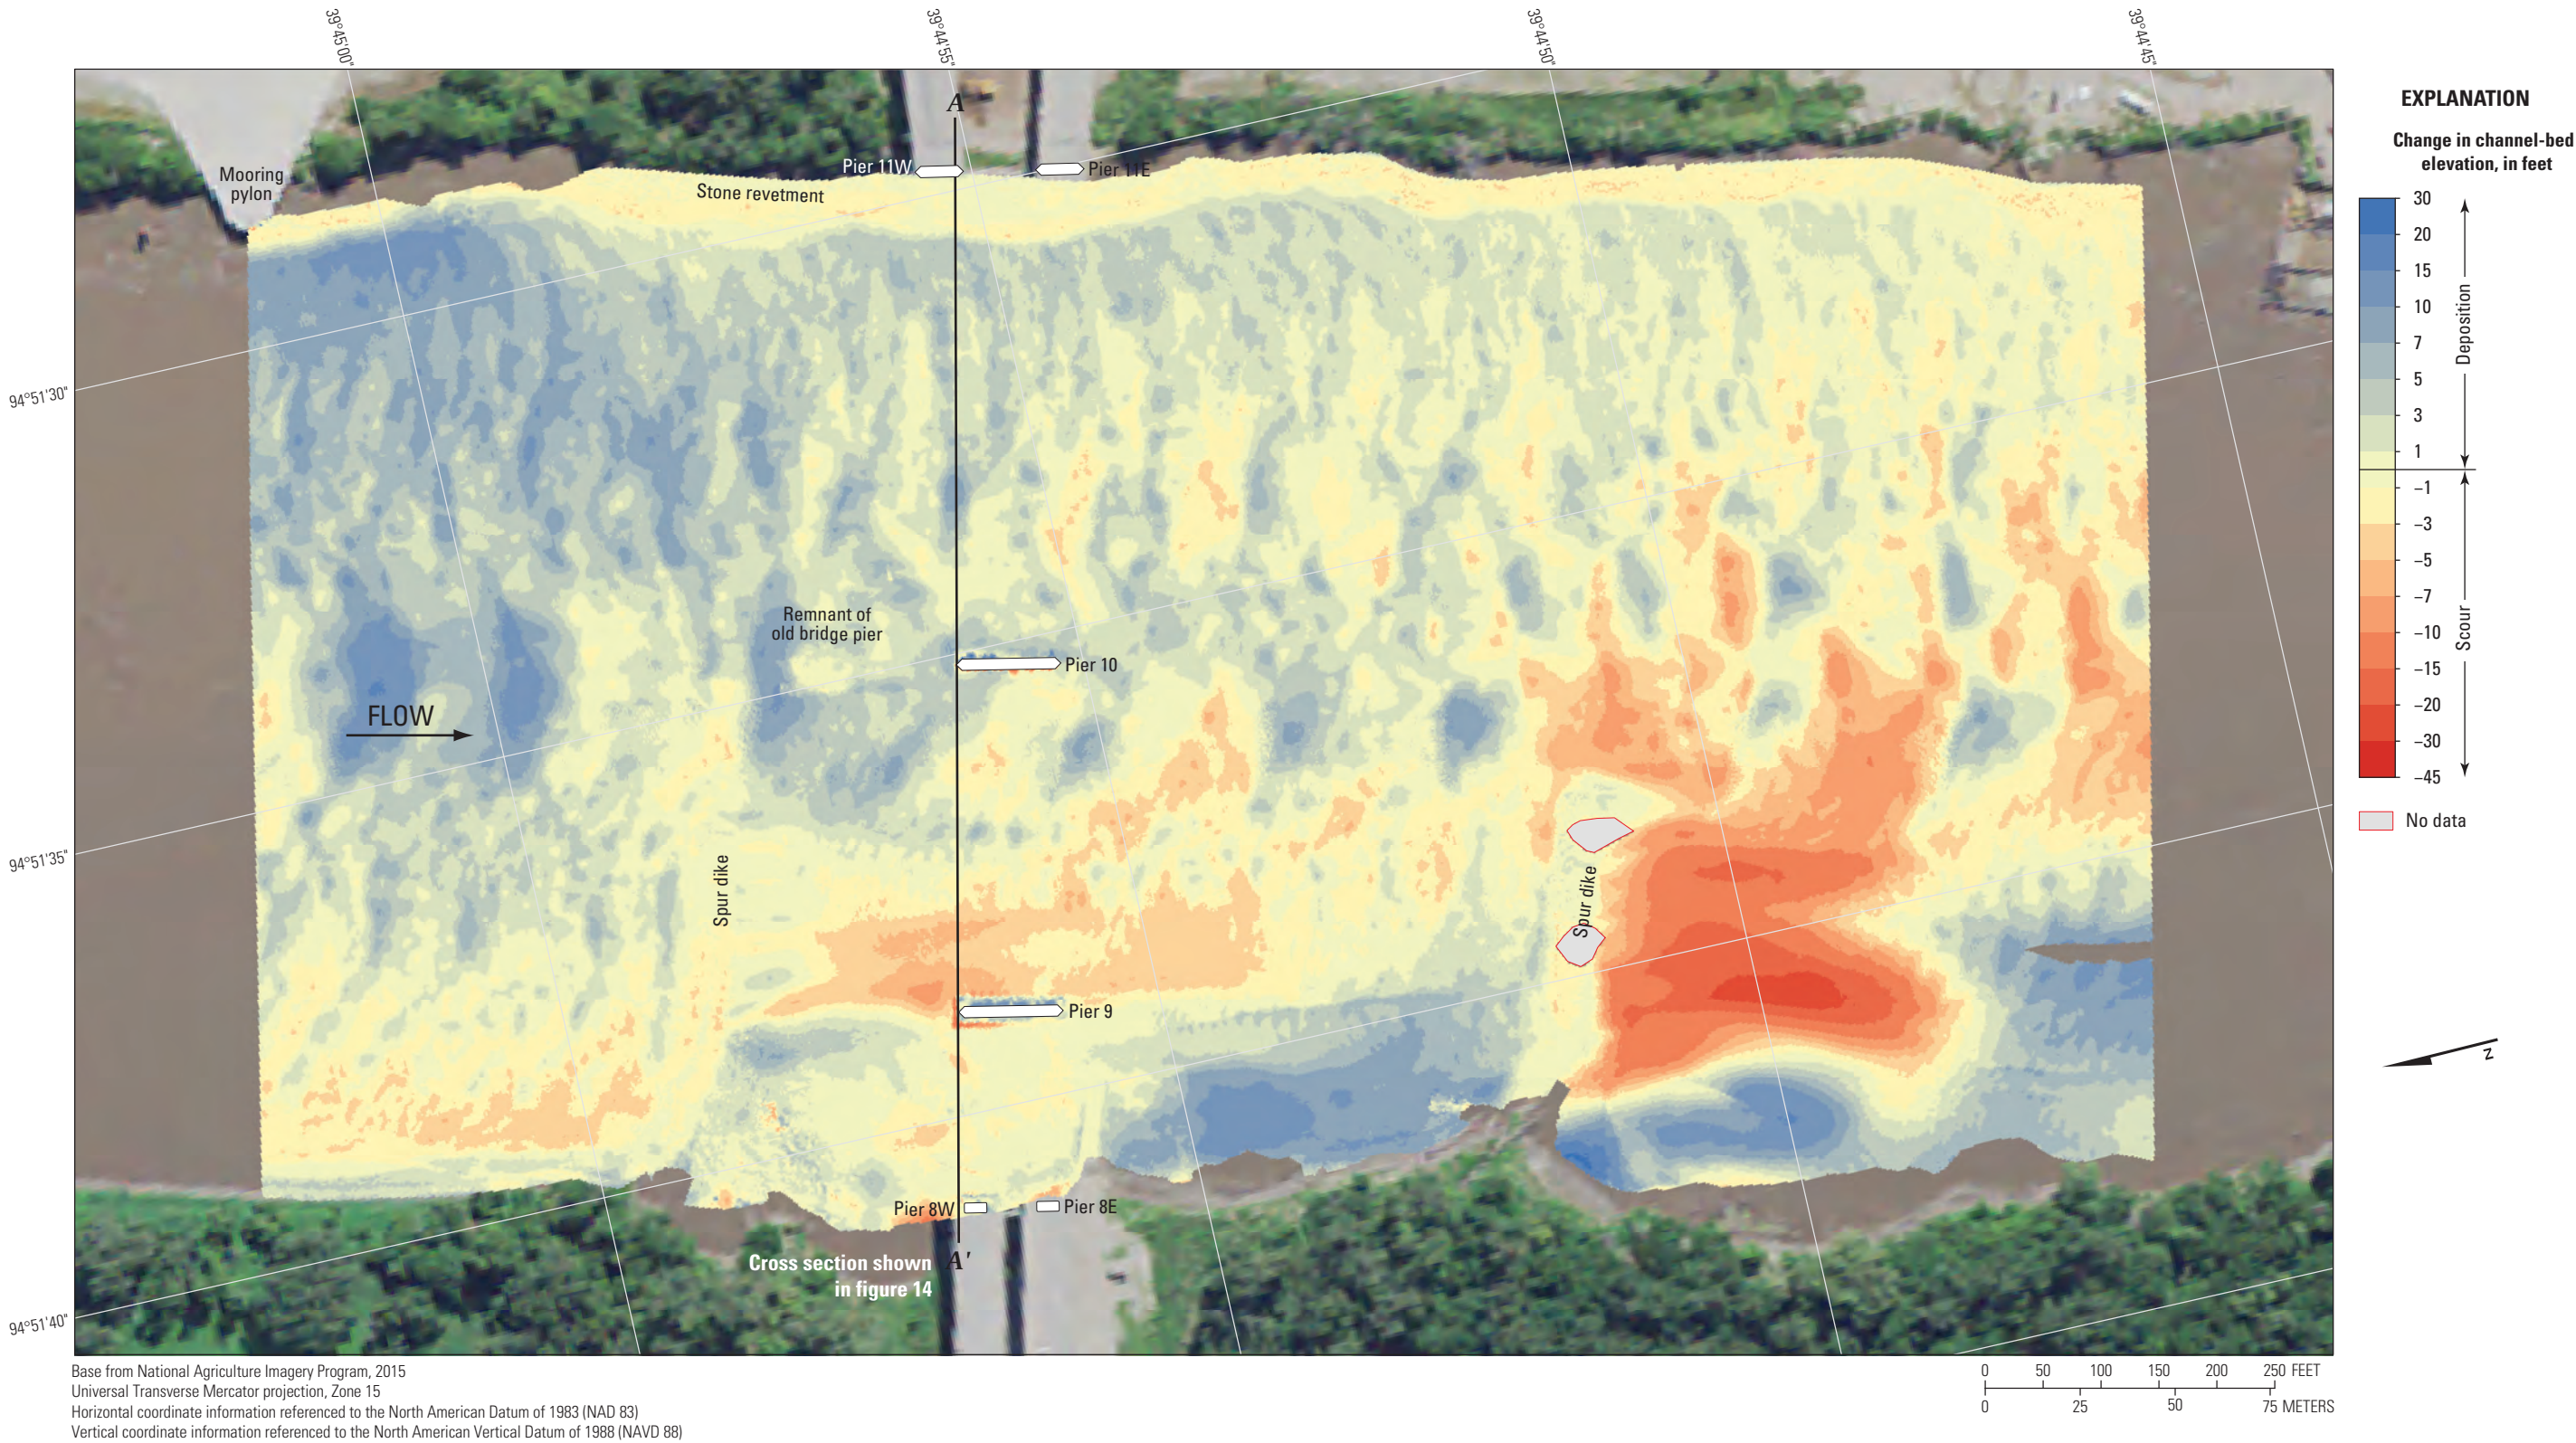
The difference between the survey on July 16, 2018, and the previous flood survey on July 14, 2011, indicates a general balance of scour and deposition throughout the reach between 2011 and 2018, except downstream from the downstream spur dike on the right (west) side of the channel where scour of as much as 20 ft was observed (fig. 16). The average difference between the bathymetric surfaces was +0.86 ft (table 8), indicating minor aggradation between the 2011 and 2018 surveys for the area common to both surveys. The net volume of cut in

**Figure 16.** Difference between surfaces created from bathymetric surveys of the Missouri River channel near dual bridge structure A3664 on U.S. Highway 36 at St. Joseph, Missouri, on July 16, 2018, and July 14, 2011.

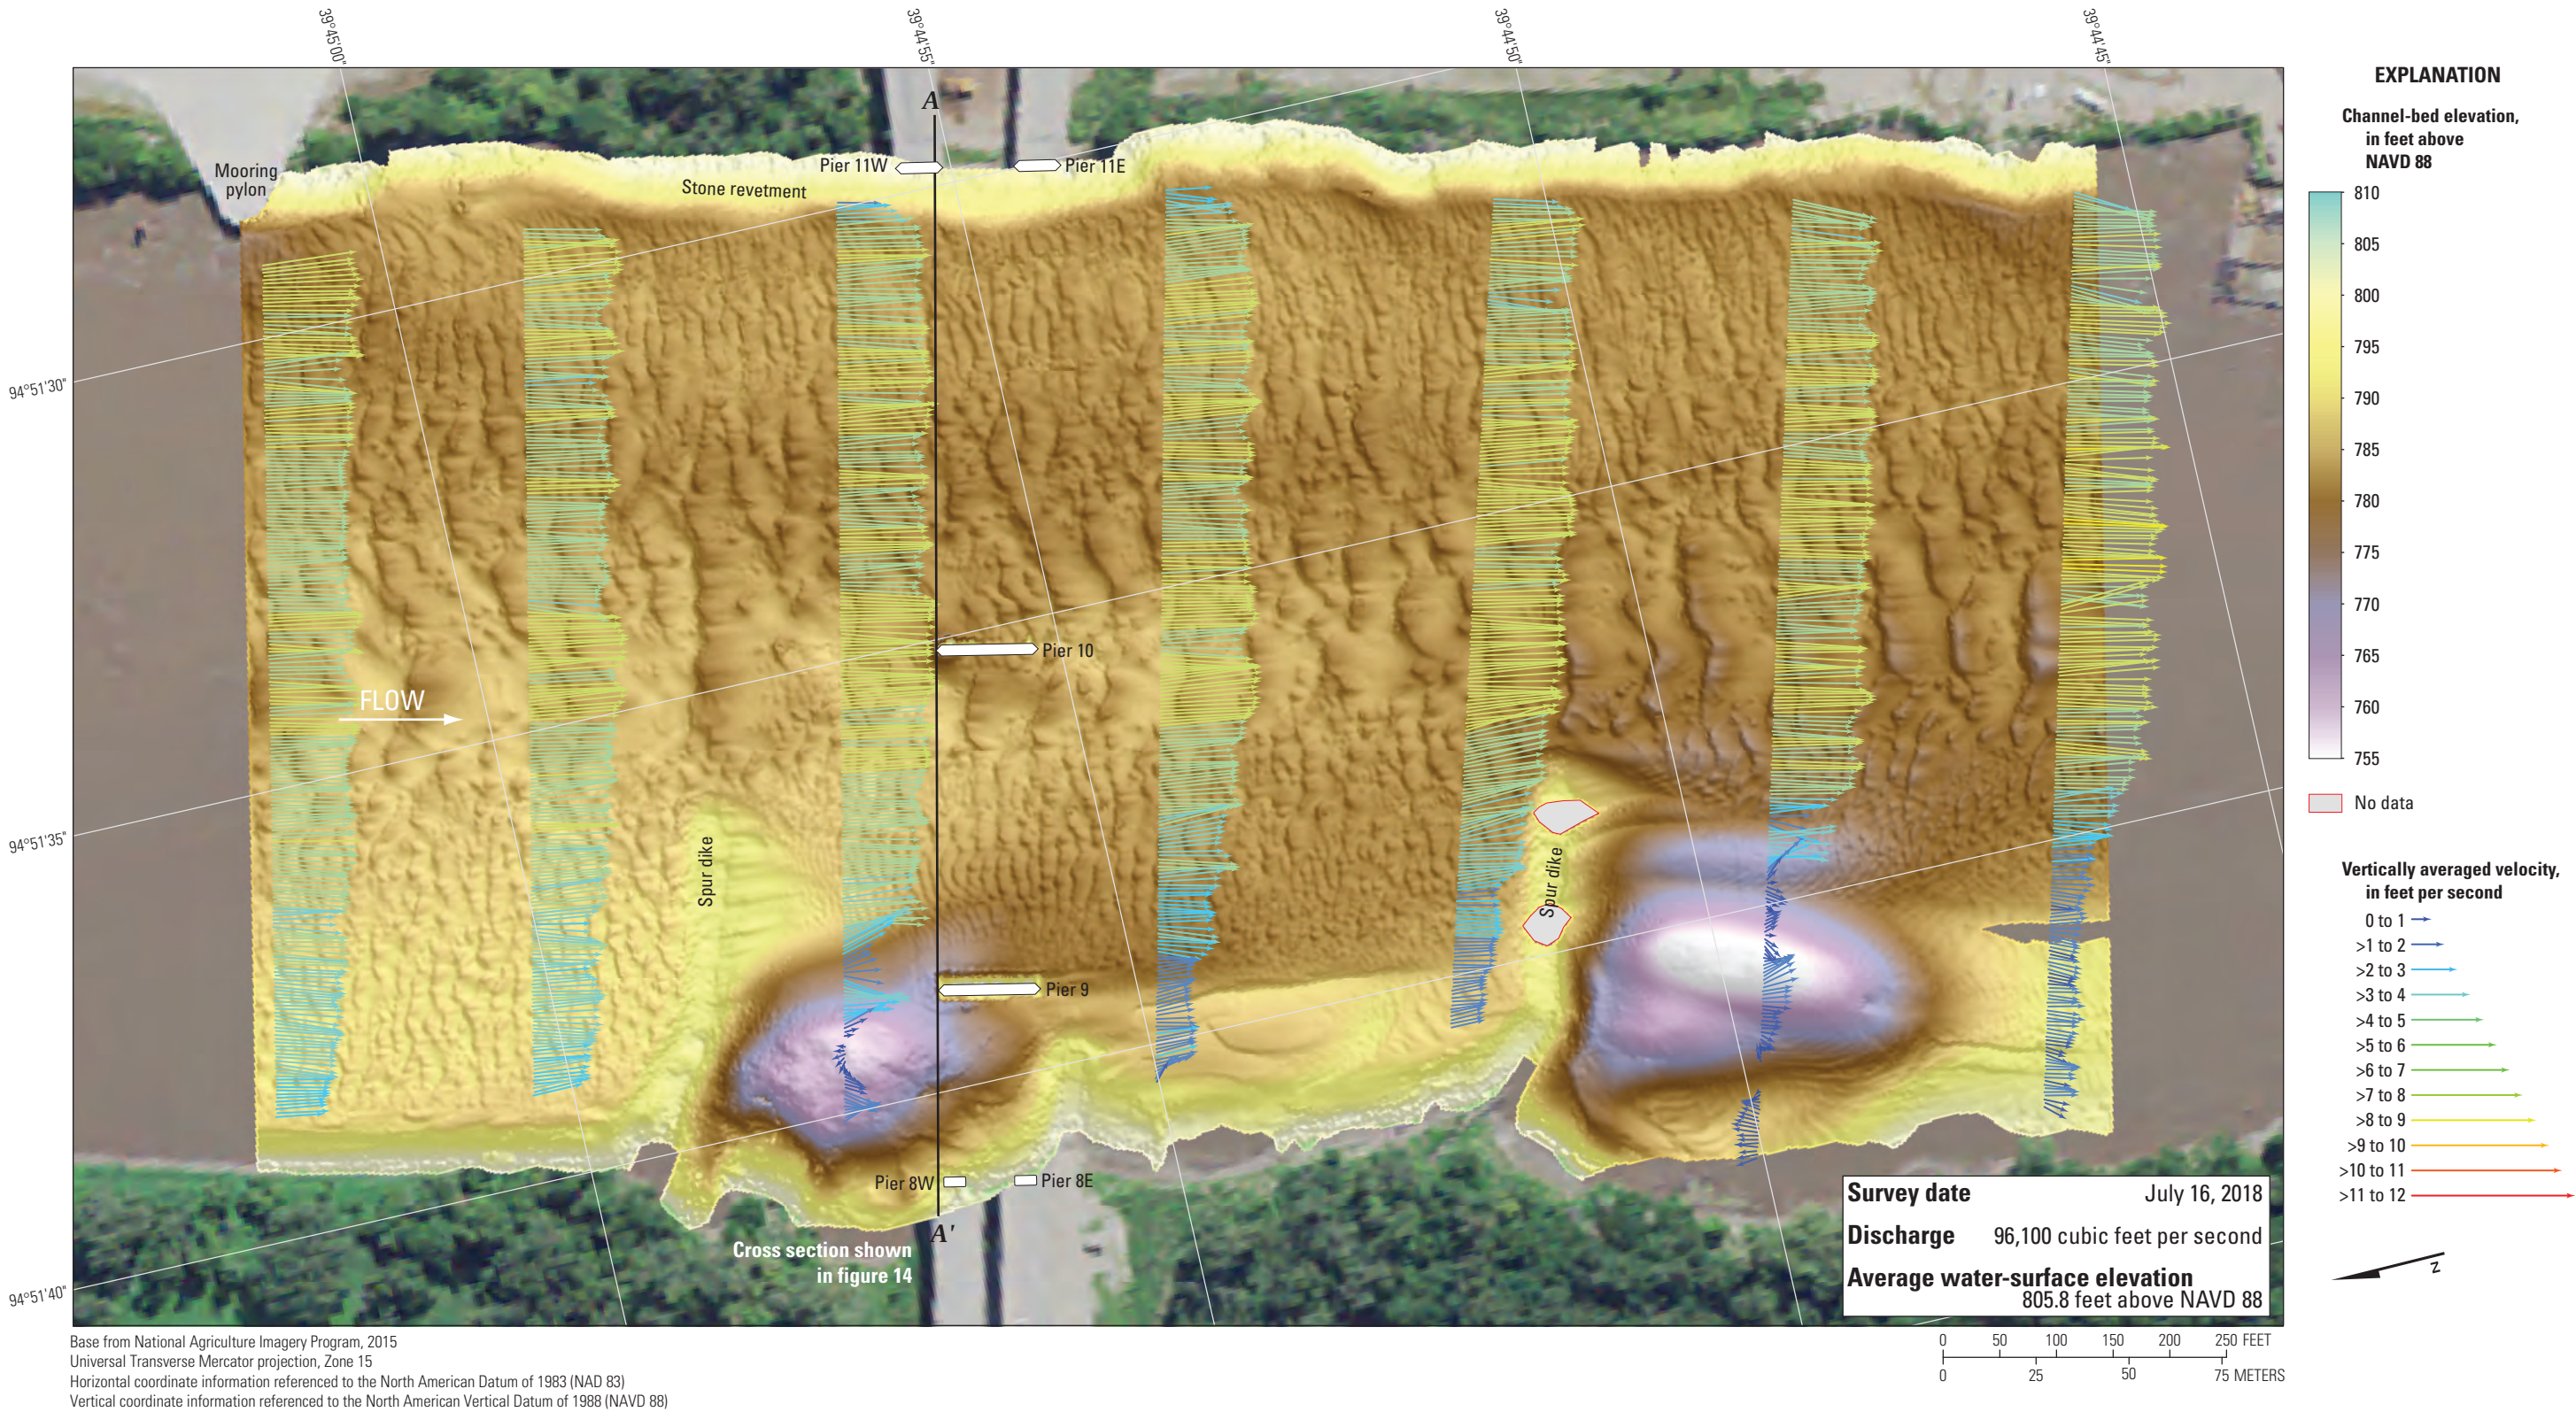
The vertically averaged velocity vectors indicate mostly uniform flow throughout the reach (fig. 17). A maximum velocity of about 9 ft/s was present in the left (eastern) side of the channel and a minimum of 1 ft/s with flow reversal was present downstream from the various spur dikes in the reach (fig. 17). Minimal to moderate turbulence was observed at several transects (fig. 17), likely as a result of localized flow disturbances caused by the spur dikes and bedforms. The bridge piers were aligned with flow, with only moderate effects on the velocity and no evident turbulence downstream from either in-channel pier (fig. 17).

**Figure 17.** Bathymetry and vertically averaged velocities of the Missouri River channel near dual bridge structure A3664 on U.S. Highway 36 at St. Joseph, Missouri.

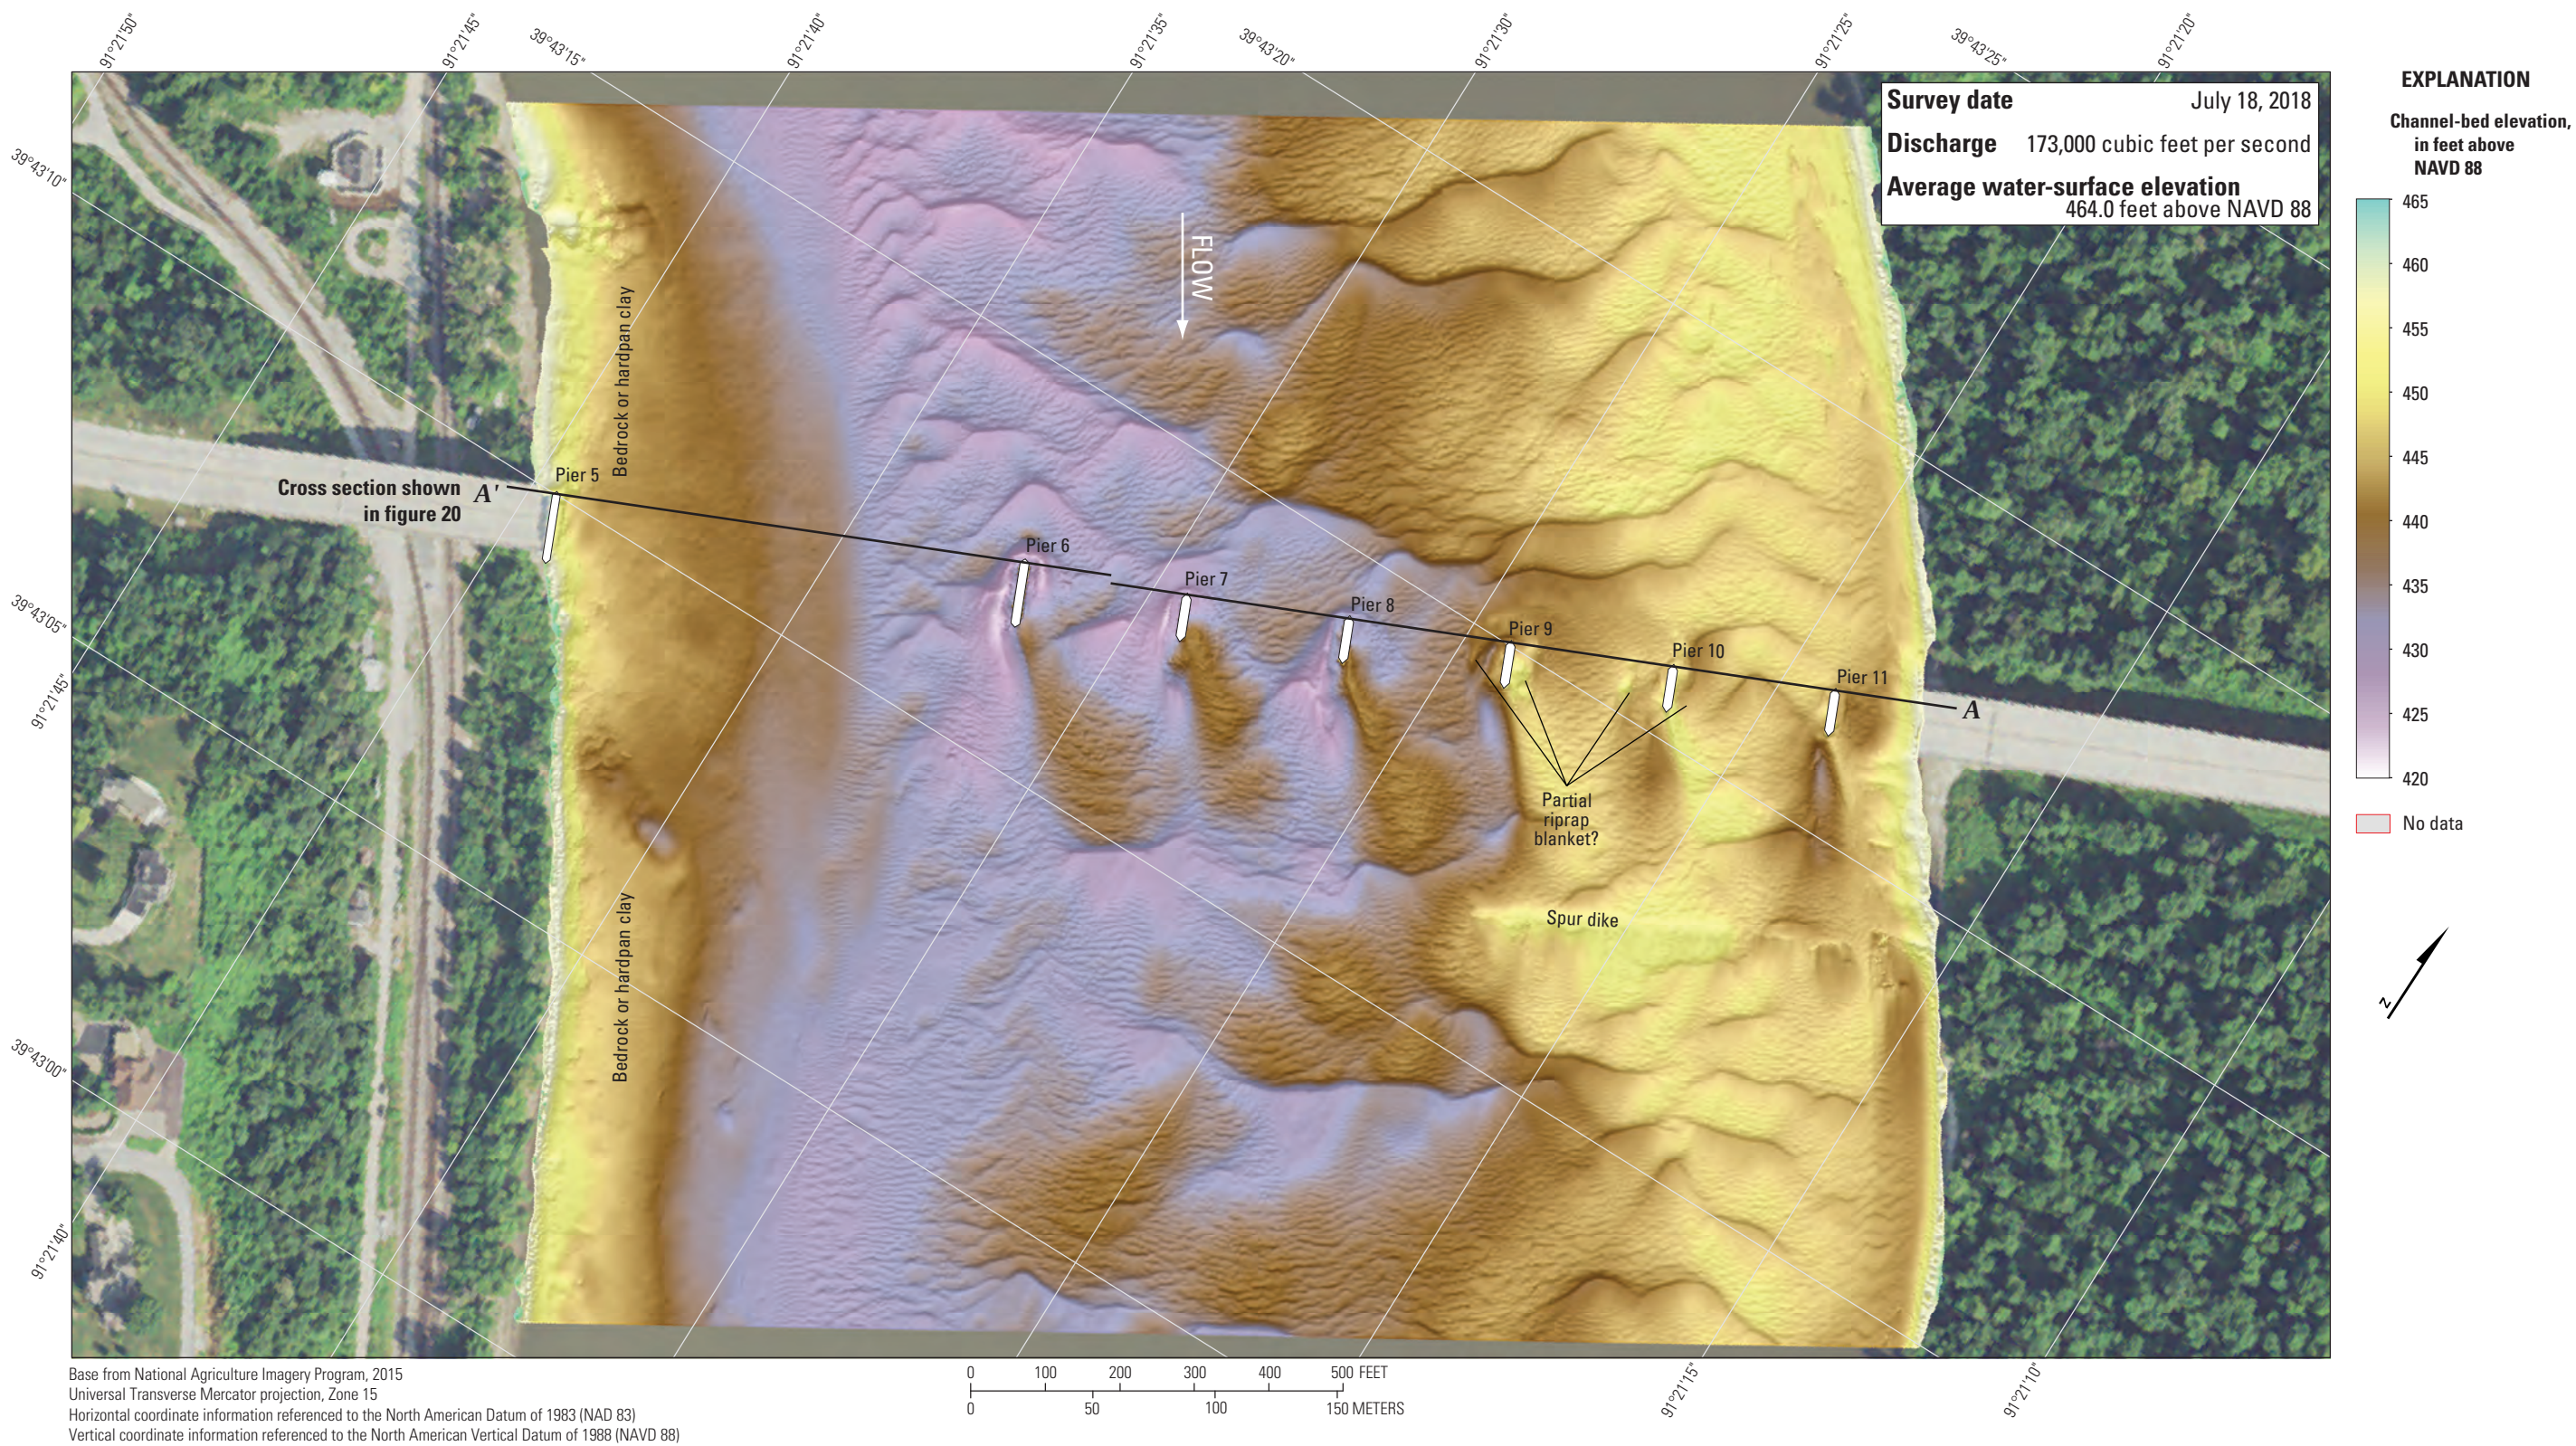
Figure 18. Bathymetric survey of the Mississippi River channel near structure A5054 on Interstate 72 at Hannibal, Missouri.

The survey area was about 1,640 ft long and about 1,870 ft wide, extending across the active channel from the left (northeast) bank to the right (southwest) bank ([fig. 18](#)). The upstream end of the survey area was about 700 ft upstream from the centerline of structure A5054, and piers 5 through 11 were in the water; however, pier 5 was in shallow water on the right bank. The channel-bed elevations ranged from about 429 to 449 ft for most of the surveyed area (5 to 95 percentile range of the bathymetric data; [table 3](#); [fig. 19](#)), except near pier 6 through 8 and the thalweg of the channel along the base of the right (southwest) bank ([table 3](#); [fig. 20](#)). The left side of the channel between the left bank and the channel thalweg was filled with small and medium dune features with superimposed ripples, and small dunes and ripples were present in the thalweg. A spur dike on the downstream left side was barely visible above the average bed nearby. The right bank seems to consist of smooth rock or hardpan clay throughout the reach, with no discernable dune features ([fig. 18](#)).

The minor scour holes near piers 10 and 11 were difficult to discern from nearby dunes and ripples, and there was no discernable hole near pier 5 on the right bank ([figs. 18, 20](#)). Alternatively, piers 6 through 8 had well-defined, asymmetric scour holes indicative of being skewed to approach flow. Pier 8 seems to have part of the footing exposed in the bathymetric map ([figs. 18, 1.4A, 1.4B](#)), and piers 9 and 10 seem to be surrounded by partial riprap blankets or piles of rock ([figs. 18, 1.3C through 1.3F](#)). Information from bridge plans

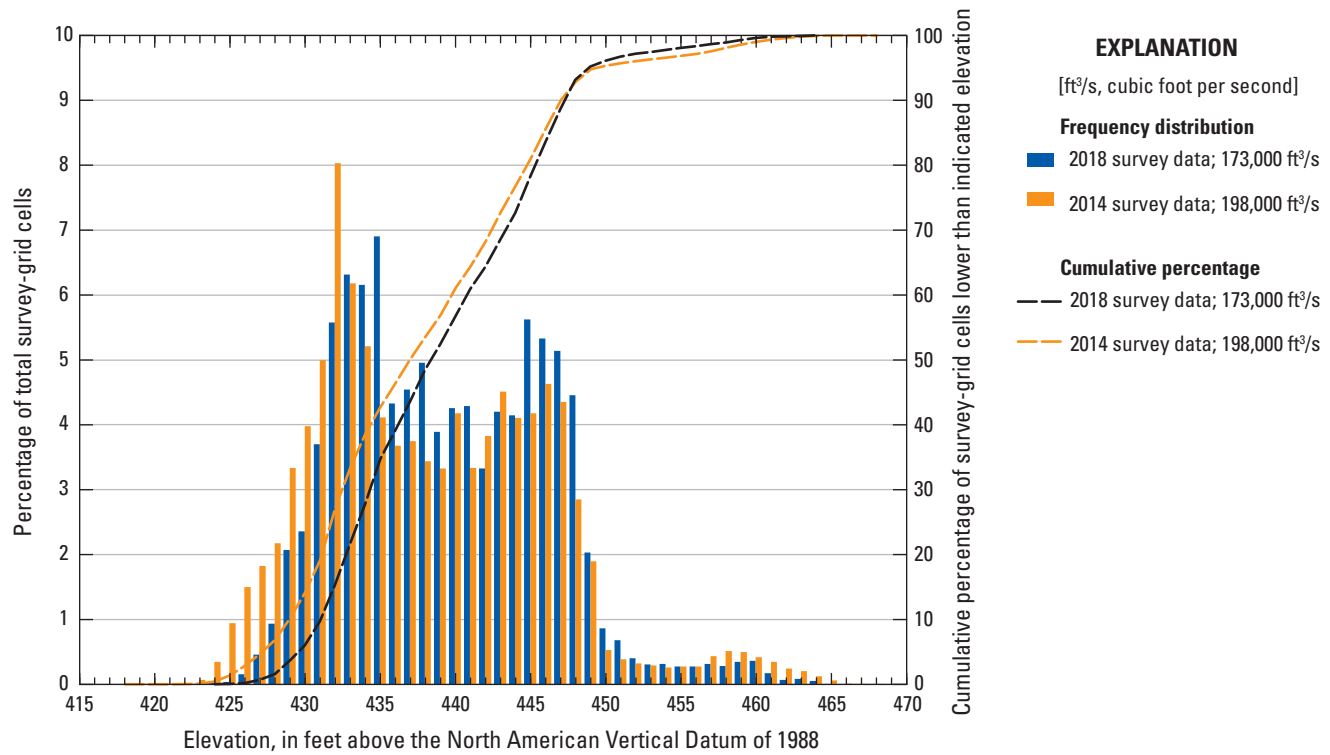
**Figure 19.** Frequency distribution of bed elevations for bathymetric survey-grid cells in 1-foot elevation bins on the Mississippi River near structure A5054 on Interstate 72 at Hannibal, Missouri, on July 18, 2018, compared to previous surveys (Huizinga, 2015).

of +1.45 ft between the bathymetric surfaces (table 8). The net volume of cut in the reach from 2014 to 2018 was about 39,800 yd<sup>3</sup>, and the net volume of fill was about 200,000 yd<sup>3</sup>, resulting in a net gain of about 160,000 yd<sup>3</sup> of sediment. There was minor deposition of as much as 5 ft along the right (southwest) bank, and a narrow bank of scour of as much as 10 ft along the left (northeast) bank compared to the 2018 survey (fig. 21). Moderate localized scour of as much as 10 ft was observed in various areas upstream, near the bridge piers, and downstream in the channel (fig. 21). The frequency distribution of bed elevations was similar in 2018 and 2014, but with a greater percentage of survey-grid cells at elevations below 432 ft in 2014 than 2018 (fig. 19).

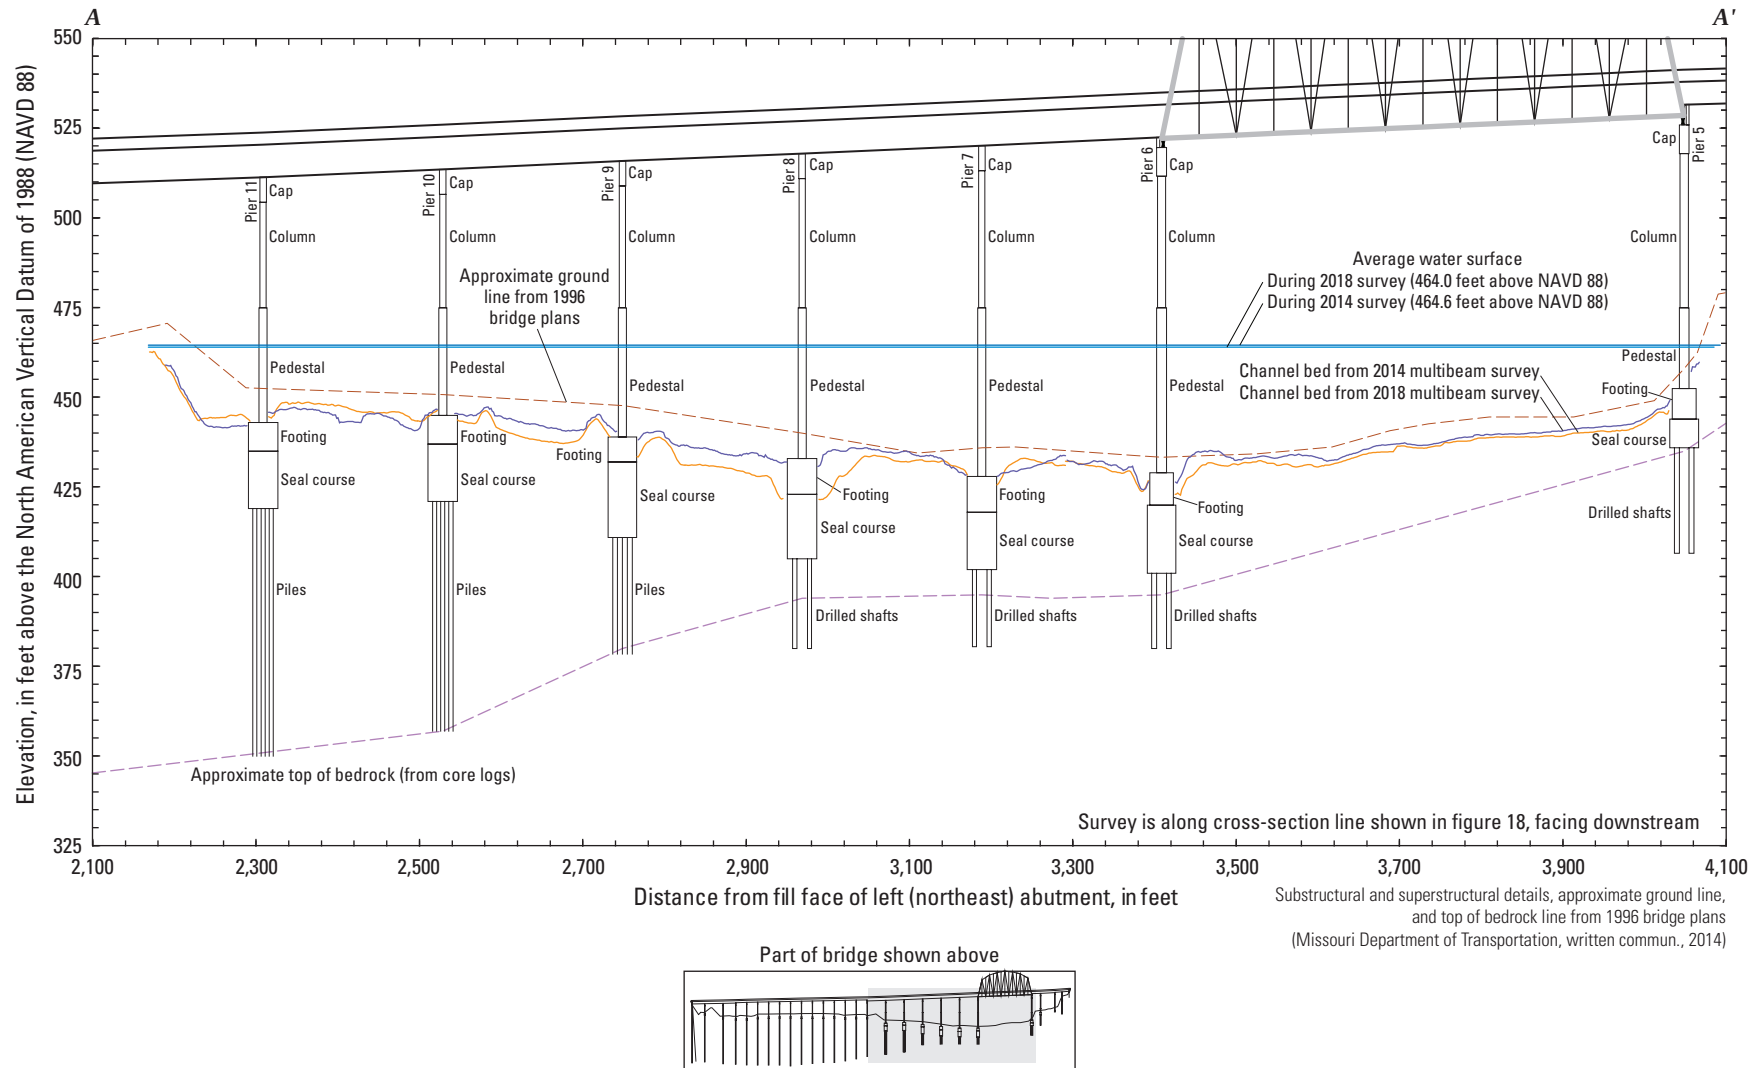
**Figure 20.** Key features, substructural and superstructural details, and surveyed channel bed of structure A5054 on Interstate 72 crossing the Mississippi River at Hannibal, Missouri.

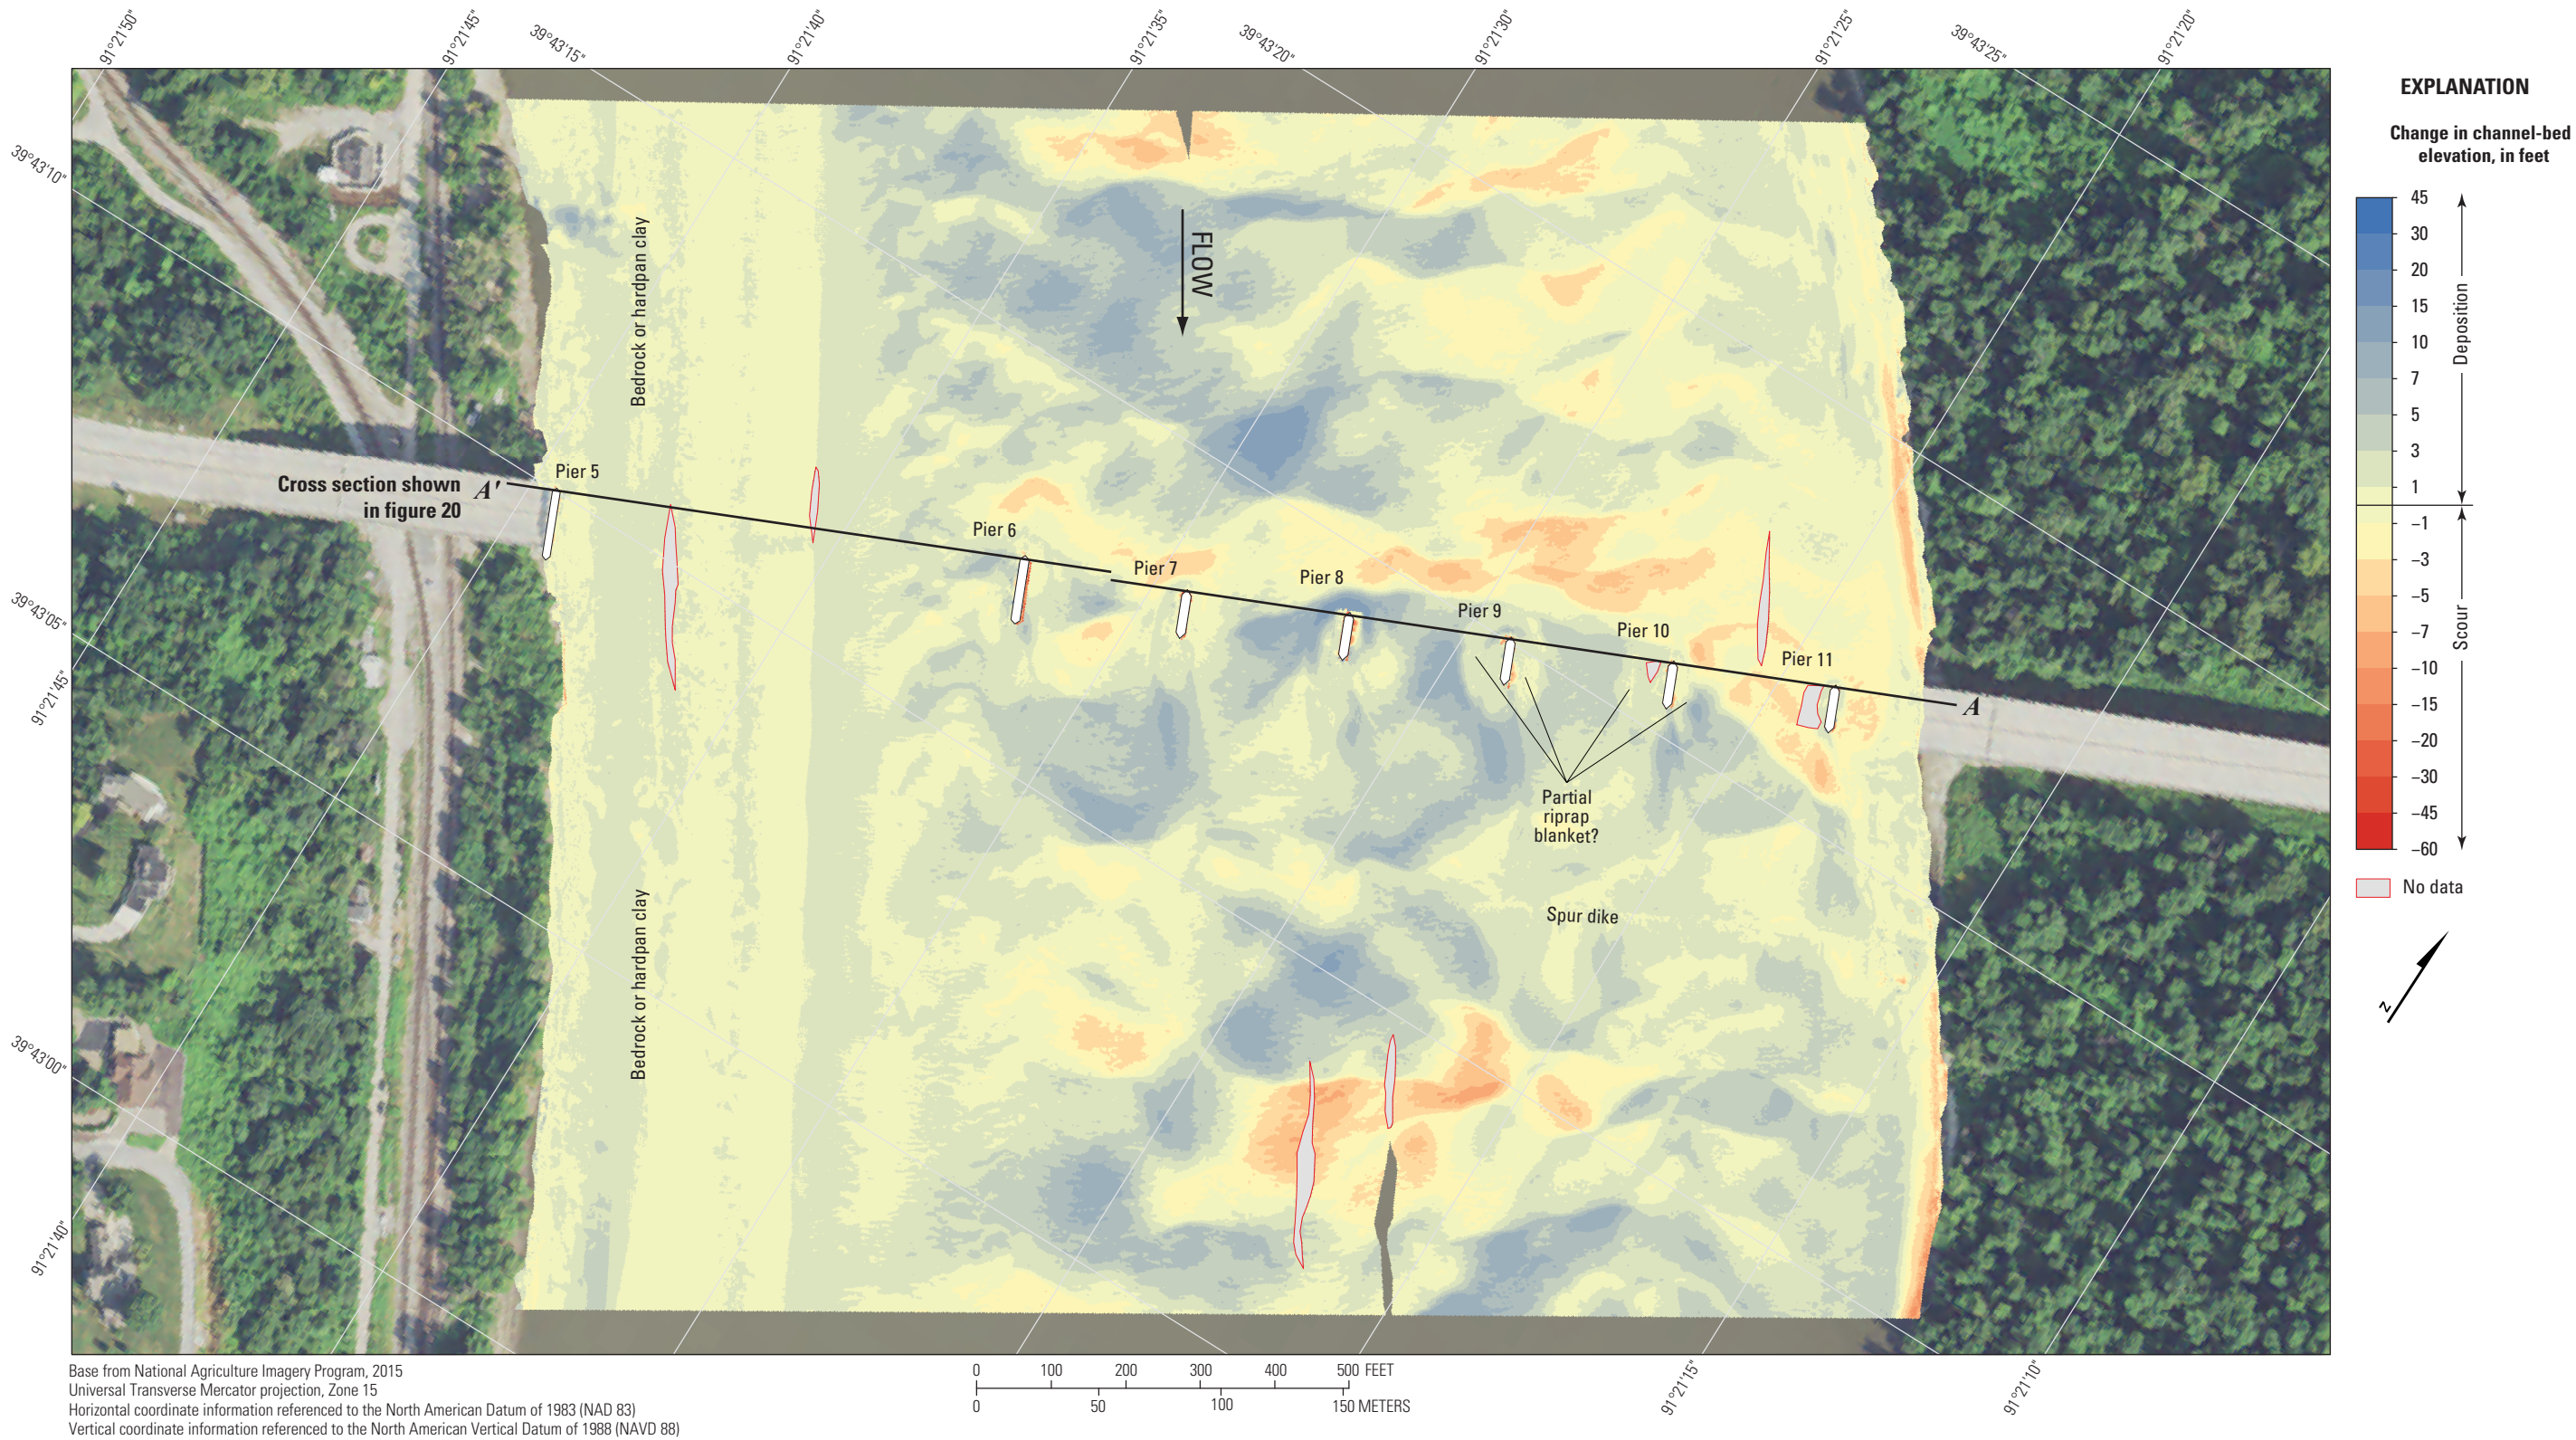
**Figure 21.** Difference between surfaces created from bathymetric surveys of the Mississippi River channel near structure A5054 on Interstate 72 at Hannibal, Missouri, on July 18, 2018, and June 5, 2014.
